TRIP AND FALL IN DEFECTIVE ROADWAY SURFACE

Pedestrian North Crosswalk

7th Avenue and West 30th Street

Date of Accident: February 5, 2019

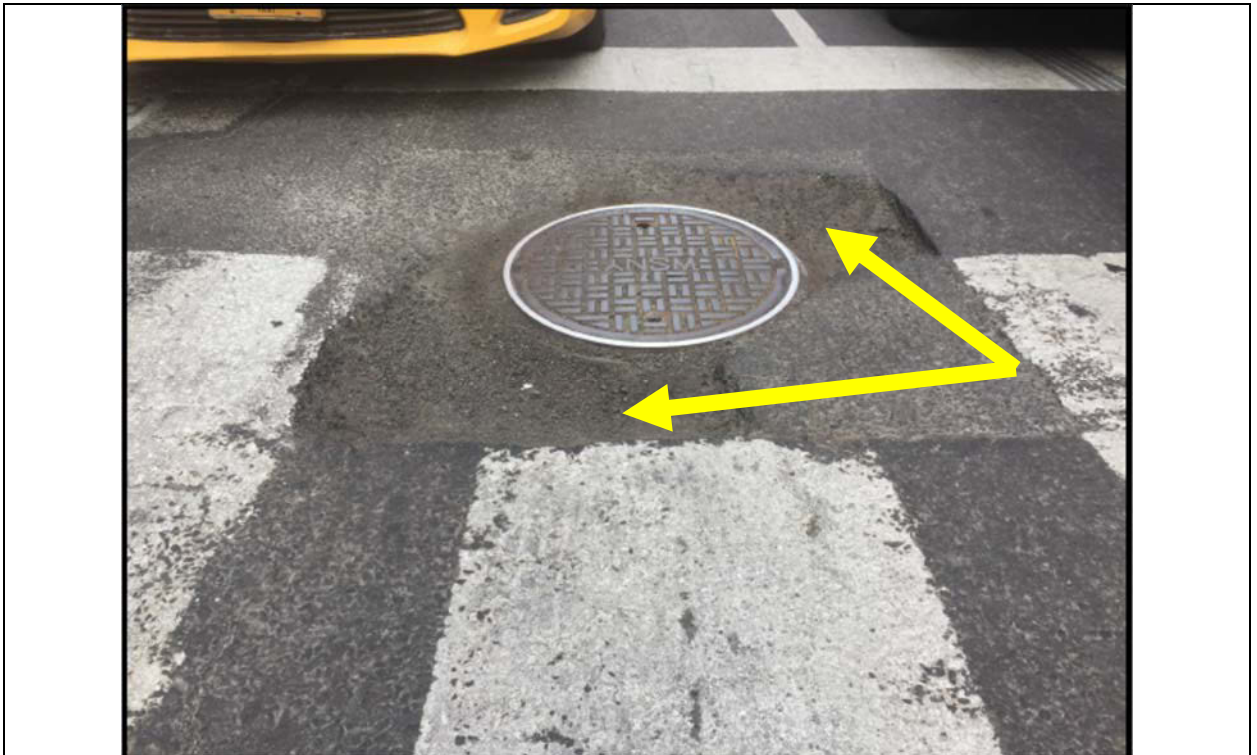
Additionally, the prior excavation was not permanently restored because the wearing course was not sealed (tack coated) at the edge of the street cuts with liquid asphaltic cement to prevent water seepage as required by Section 2-11(e)(12)(viii) of the Highway Rules. The asphalt that was supposed to surround the manhole casting (frame) was not in place and created a depression 3-4 inches in depth as depicted in the photograph below.

Figure 1. The solid arrows show the depression where Plaintiff tripped and fell, and is of what appears to be a temporary restored excavation. There is no asphalt cement (tack coat) surrounding the perimeter of the excavation or liquid asphaltic seal which would indicate that the excavation was permanently restored.

arrived at the Pothole, the pavement and atmospheric temperatures were below the 40 degree minimum temperature recommended for applying temporary fill greater than three (3) inches deep to the wearing course. See Section 402-3.01, Temperature and Seasonal Limitations, of the New York State DOT Standard Specifications. This is consistent with the December 7, 2018 Gang Sheet which notes that the Hotbox carrying the temporary fill malfunctioned and could not get above 125 degrees Fahrenheit, and as a result the cold asphalt had to be dumped. Based on the cold atmospheric temperatures, cold asphalt, and malfunctioning Hotbox, the temporary fill placed by the DOT Crew on December 7, 2018 could not adhere to the bottom and sides of the depression and therefore was not secured within the depression. The improper patch to begin to fail almost immediately and created an immediately dangerous condition. The immediate failure of the temporary fill on December 7, 2018 was also impacted by vehicles braking and accelerating on the heavily trafficked roadway, loosening, dispersing and crumbling the improper patch and causing the deep defect around the manhole cover and casting as depicted in Figure #1.

was not in place and created a depression between three inches to four inches in depth as depicted in the photograph in Figure #1.

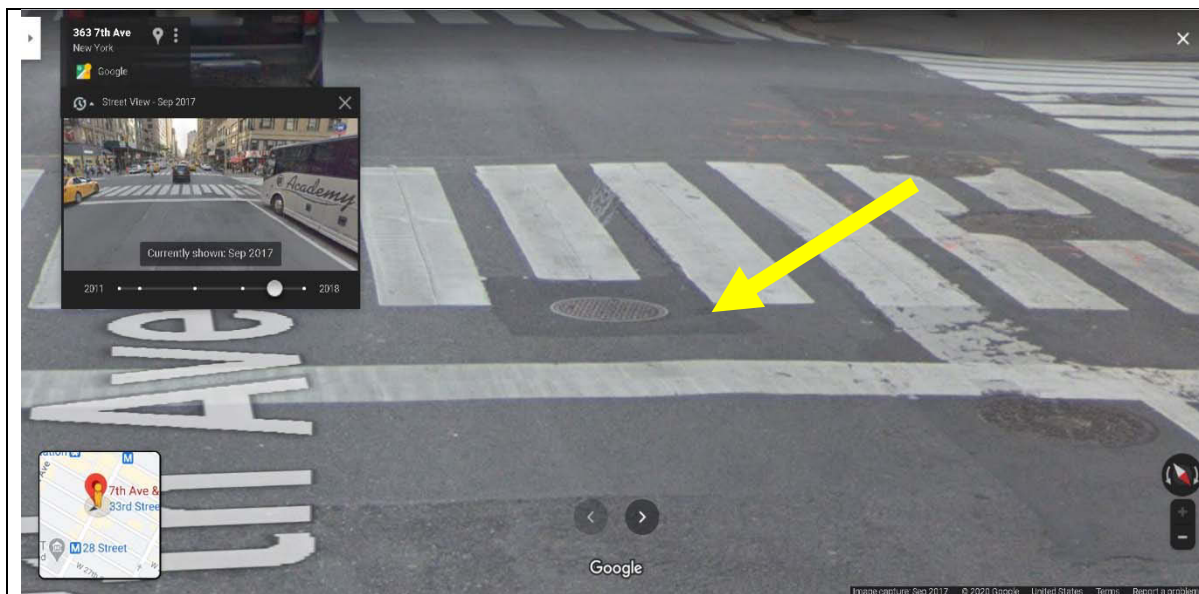
Figure 2. The arrow points to said manhole located in the north crosswalk of 7th Avenue and West 30th Street. Note that there is no asphalt cement and seal (tack coat) around the perimeter of the temporarily restored excavation that was performed by the DEP on May 5, 2017. This indicates that the excavation was not permanently restored as required by the Highway Rules. The Google Street View photograph is dated September 2017, approximately four (4) months after the DEP's water valve repair and excavation.

Referring to Figure 2 above, the water valve excavation performed by the DEP on May 5, 2017 was not permanently restored and therefore the temporary restoration of the excavation allowed storm water to penetrate the asphalt and cause failure to the subgrade as well as to deteriorate the asphalt due to freeze/thaw cycles in the winter months. The deteriorated asphalt developed into a deep depression and on December 7, 2018 a DOT Gang Crew was dispatched because of the complaint about the depression made by Kim Salvo, a member of the general public. However, on December 7, 2018 at approximately 10:50 PM when the DOT Crew purportedly

III. Referring to Figure 2 above, the repaired water valve excavation performed on May 5, 2017 was not permanently restored and therefore the temporary restoration of the excavation allowed storm water to penetrate the asphalt and cause failure to the subgrade as well as to deteriorate the asphalt due to freeze/thaw cycles in the winter months.

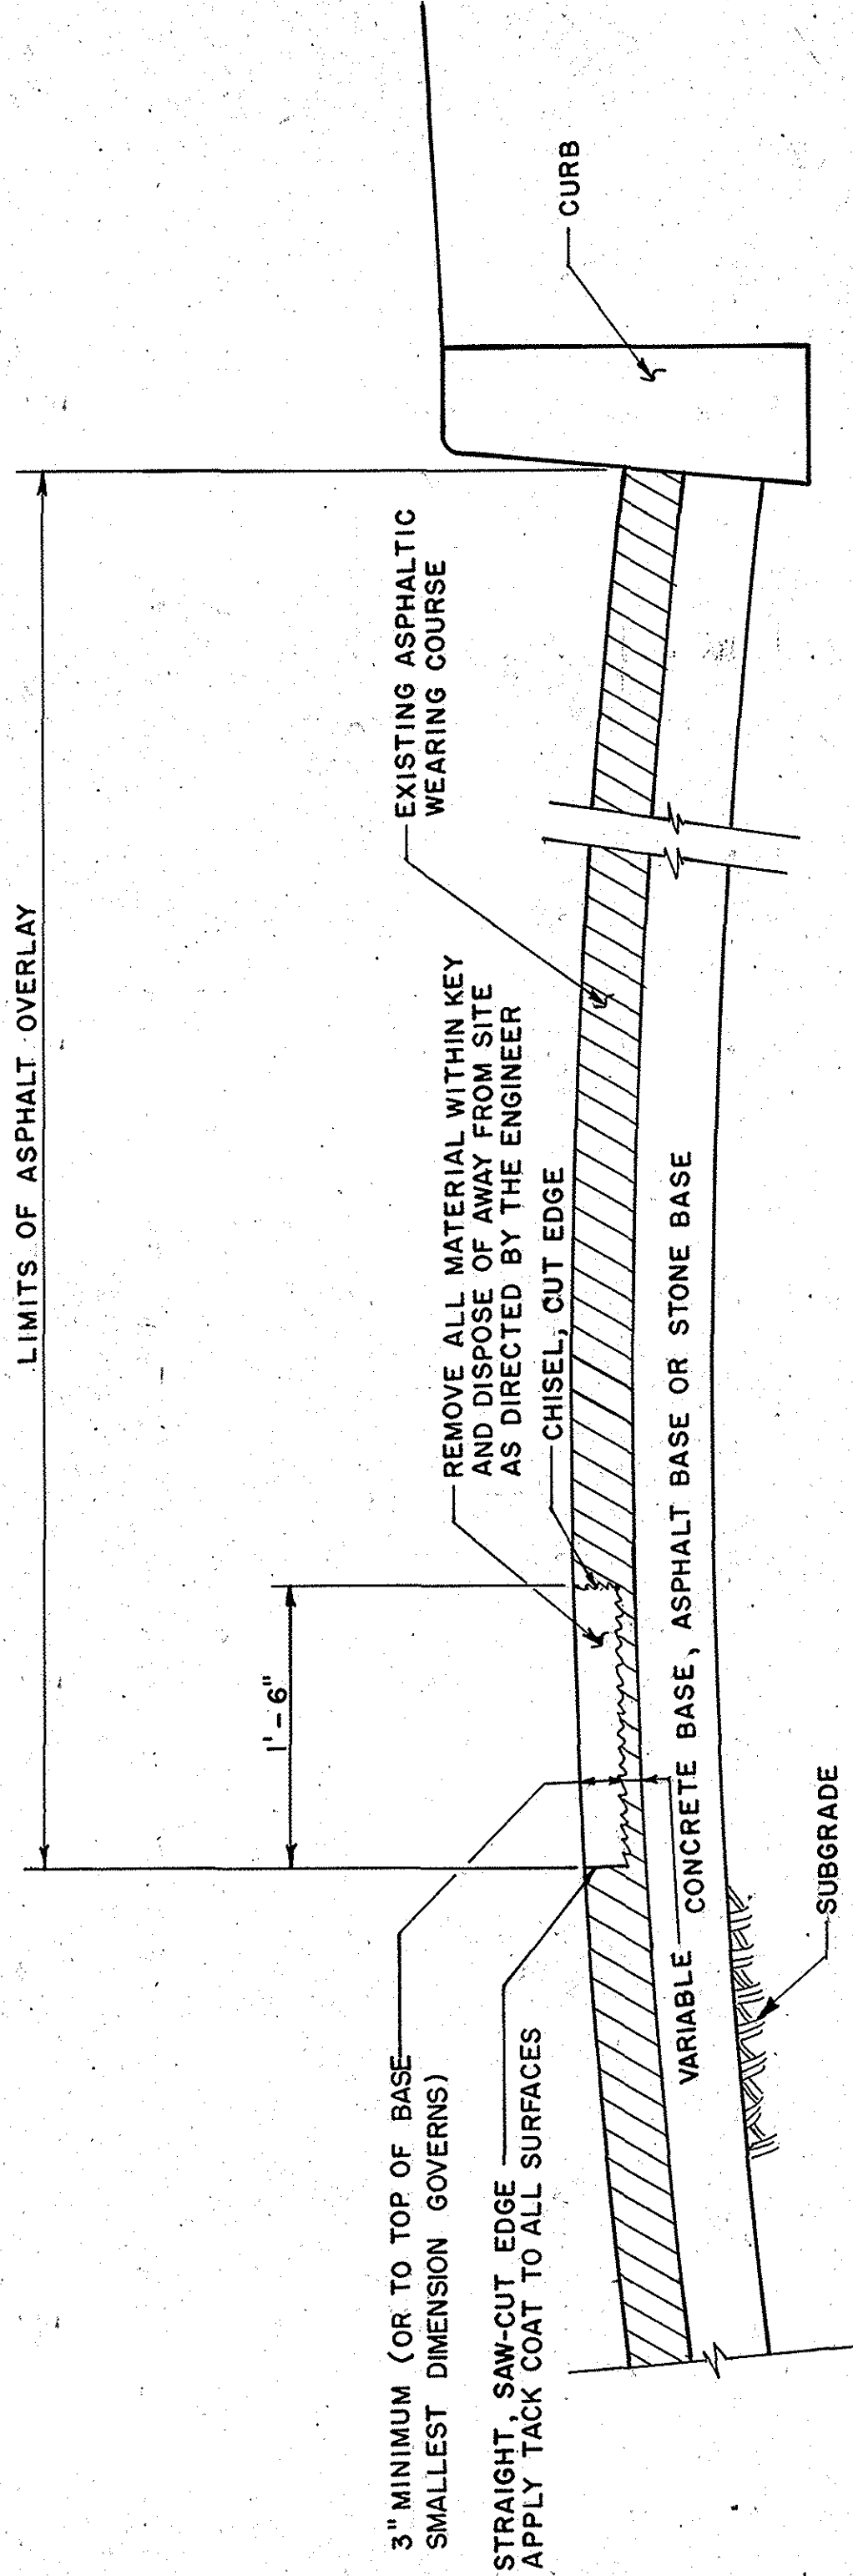
CITY OF NEW YORK DEPARTMENT OF TRANSPORTATION BUREAU OF HIGHWAY OPERATIONS	TYPICAL PAVEMENT KEY	
	DATE: 3/10/80 H-1031	R 79

1) The inspection of the photographs of the roadway on 7th Avenue and West 30th Street, Manhattan, New York, as they existed at the time of the incident show that the street surface surrounding the New York City water supply manhole was in a dangerous and defective condition. The photographs show that there was a prior rectangular excavation that was not permanently restored as required by Section 2-11(e)(12)(x) of the New York City Department of Transportation Highway Rules (the "Highway Rules"). The prior excavation was not permanently restored because the street cuts made to the "wearing course," which is the top layer of pavement, did not have asphalt cement (tack coat) surrounding the perimeter of the rectangle cuts flush with the pavement on all sides and conforming to the NYC DOT Standard Specifications and Standard Detail Drawings, Drawing H-1031, as required by Section 2-11(e)(12)(ii) of the Highway Rules.
